# The tub doesn't hold water.

## Solution: The linkage assembly needs readjusting.

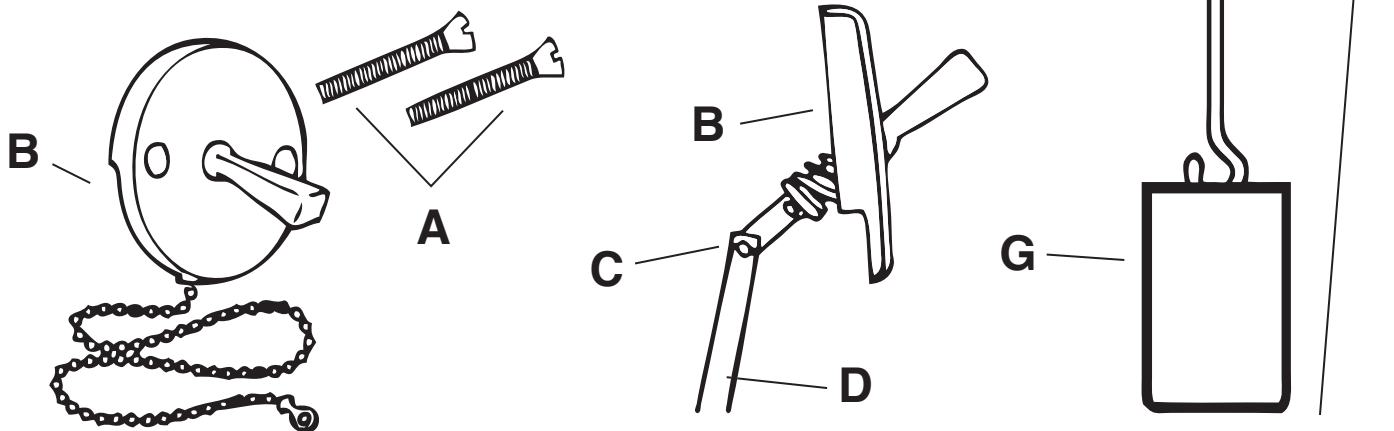
1. Remove screws (A) from old overflow plate (B).
2. Detach plate from linkage (D) by removing cotter pin (C).
3. Pull entire assembly out through the overflow (E).
4. Loosen the assembly's adjusting nuts (F), located on the bottom end of the striker rod, and slide the middle link and striker spring up to shorten
5. Clean the plunger (G), then reinstall.
6. Align screw holes on your new Danco overflow plate and thread screws into place. Tighten with a screwdriver.

1. Retirar los tornillos (A) de la placa usada de rebose (B).
2. Separar la placa de la articulación (D) retirando el pasador (C).
3. Saque el ensamblaje completo por el desbordamiento (E)
4. Afloje el ensamblaje ajustando las tuercas (F) localizadas abajo de la barra de, y deslice el acoplamiento medio y el huelguista se origina para acortarse
5. Limpie el tapon (G) y re- instale.
6. Alinear los agujeros para tornillos en su nueva placa Danco de rebose y entornillar los tornillos en su sitio. Ajustar con un destornillador.
